# Project Case Study: Sweet Street, Leeds

The Sirius Group: Confidence you can build on

Project: Demolition of 3 former factory buildings, Sweet Street, Leeds City Centre

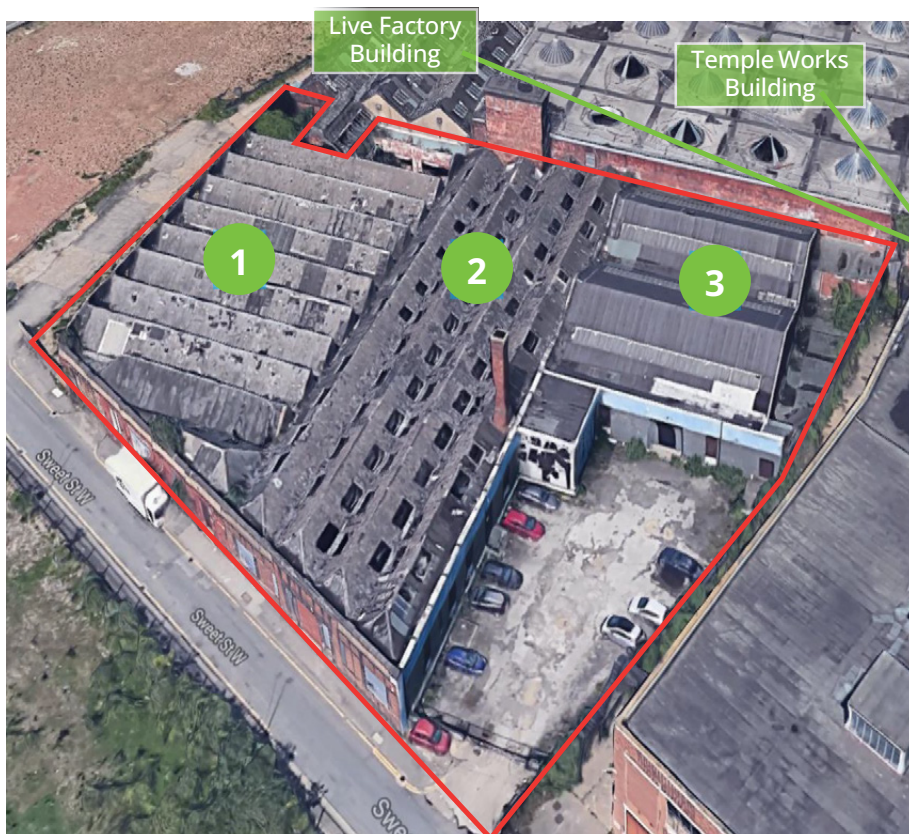
The buildings on the site were located immediately to the south of an operational factory building, and the Grade I listed Temple Works Main Mill building.

Aerial view of the site and the three buildings to be demolished

Because of the close proximity of these buildings to the buildings requiring demolition the works required careful planning, frequent liaison with the design team, regulators, and site neighbours.

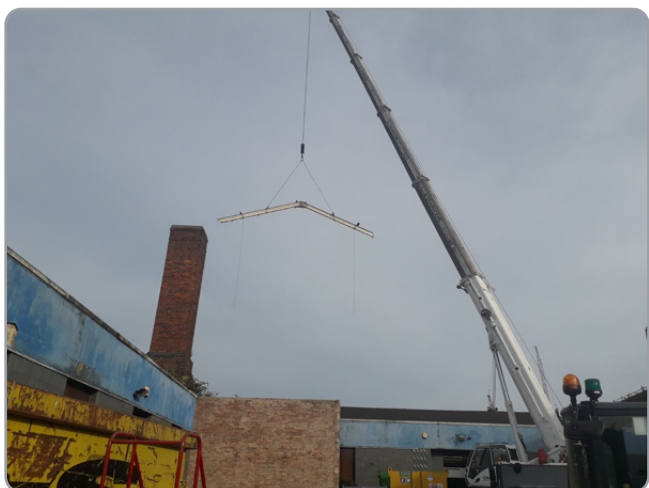
Steel roof trusses being removed by crane from Building 3

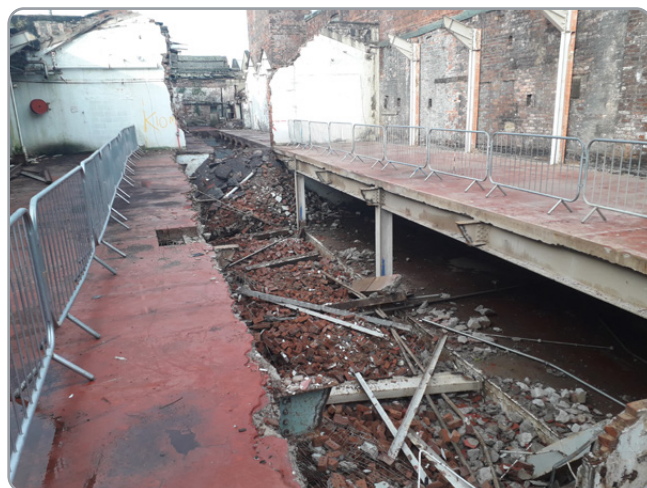
Break in slab and arches within Buildings 3 & 2 respectively

The 3 buildings requiring demolition were each constructed differently, two of the buildings also contained basements, therefore a good understanding of their construction was required to safely demolish each building. Specialist small demolition plant was utilised on the ground floors spanning basements so as not to impose significant loads on the floors.

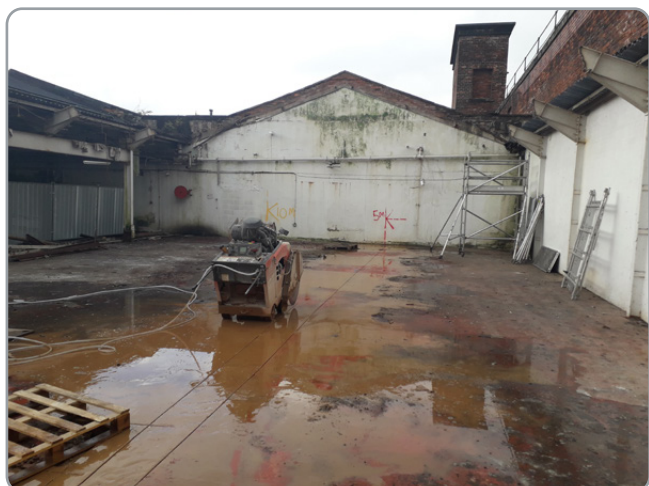
Building 3 Suspended floor - Saw cut along 5.0m off-set with Temple Works

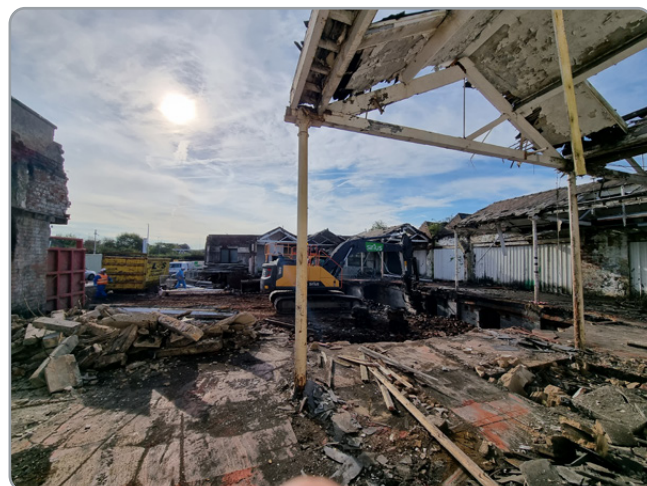
Demolition progressing in Building 3

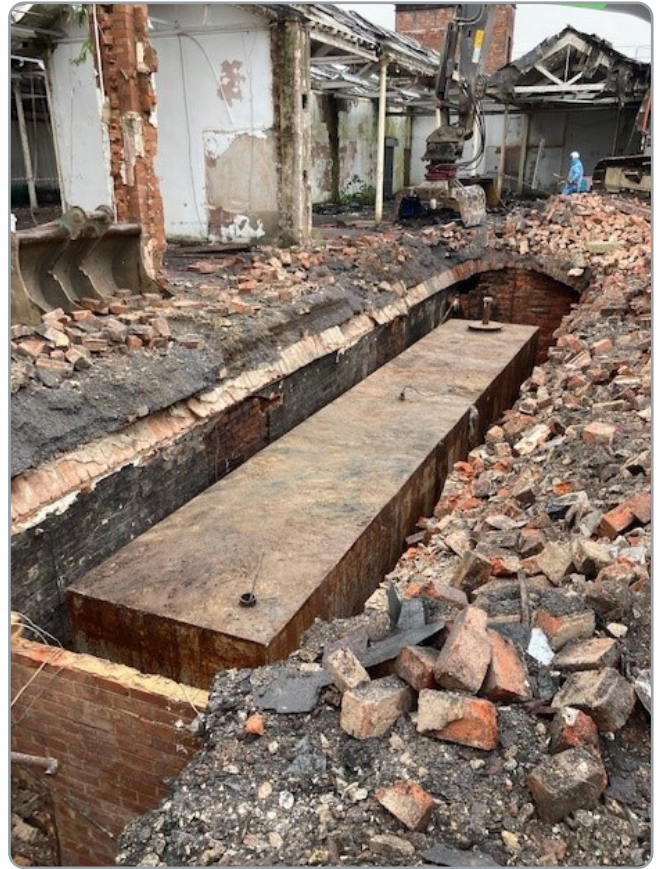
Heating oil tank inside one of the arches in Building 2 – tank contains heavy heating oil. To be cleansed/degassed and removed

- Removal of all asbestos containing materials.
- Soft stripping internals of all buildings.
- Vibration monitoring and reporting throughout.
- Safe retention of all heritage materials such as stone setts, coping stones, bricks, and cast-iron columns.
- Decommissioning and removal of a heavy heating oil tank not known about at tender stage.
- Facilitate phased ground investigation undertaken in 3 parts as each building was demolished.
- Crushing of all hard standings and other hard materials to produce recycled aggregates for reuse on site.
- Reengineering of site won soils.
- Full validation of the works via chemical and geotechnical testing to demonstrate compliance with the Earthworks Specification & Remediation Statement.

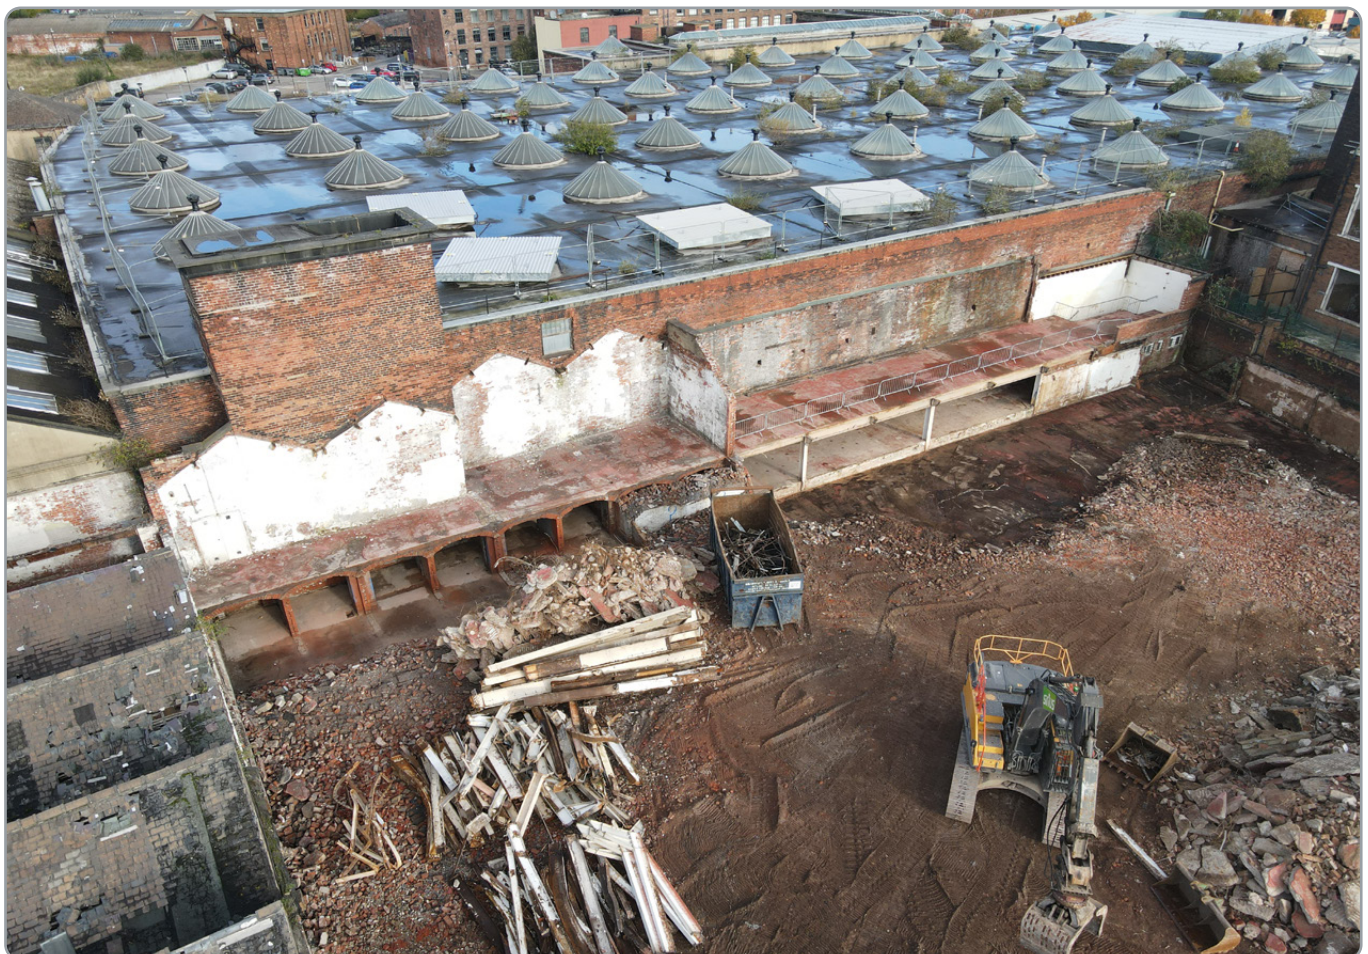
Drone image showing remnants of Building's 2 & 3 with Temple Works in the background (image courtesy of Arup)

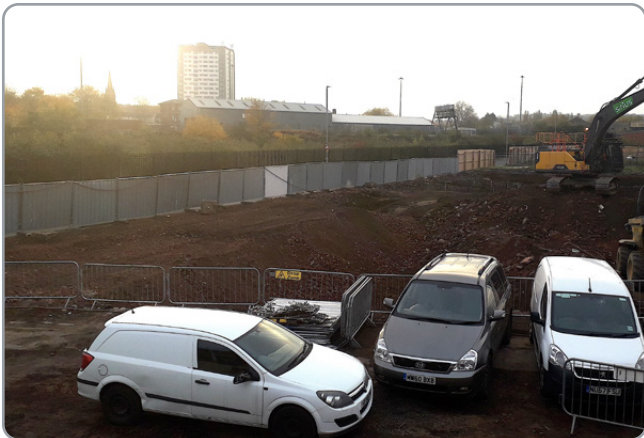
Sweet Street façade removed and replaced with temporary fencing

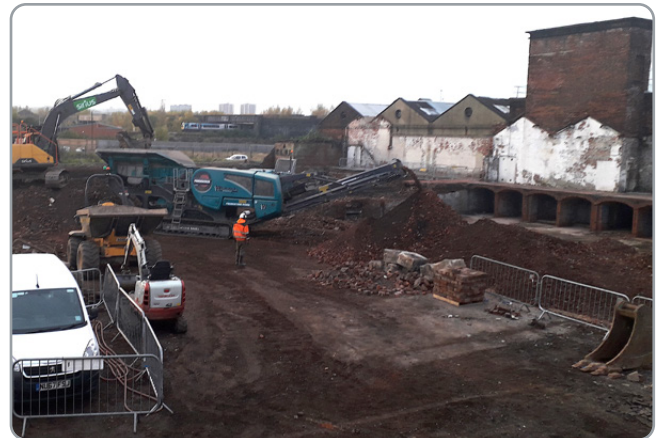
Crushing hard materials

Soft stripping and removal of all asbestos containing materials. Demolition of existing buildings by hand and mechanical methods. Real time vibration monitoring was undertaken to ensure the demolition works didn't damage the neighbouring listed building. Safe decommissioning and removal of fuel both known and unknown at the tender stage. Remediation of any additional contamination identified following demolition of the buildings. Crushing of all hard standings and other hard materials to produce a recycled aggregate for reuse on site and reengineering of site won soils.
